Submission to the

**American Airlines Flight 587  
Belle Harbor, New York  
November 12, 2001**

**Accident Investigation**

AIRBUS S.A.S

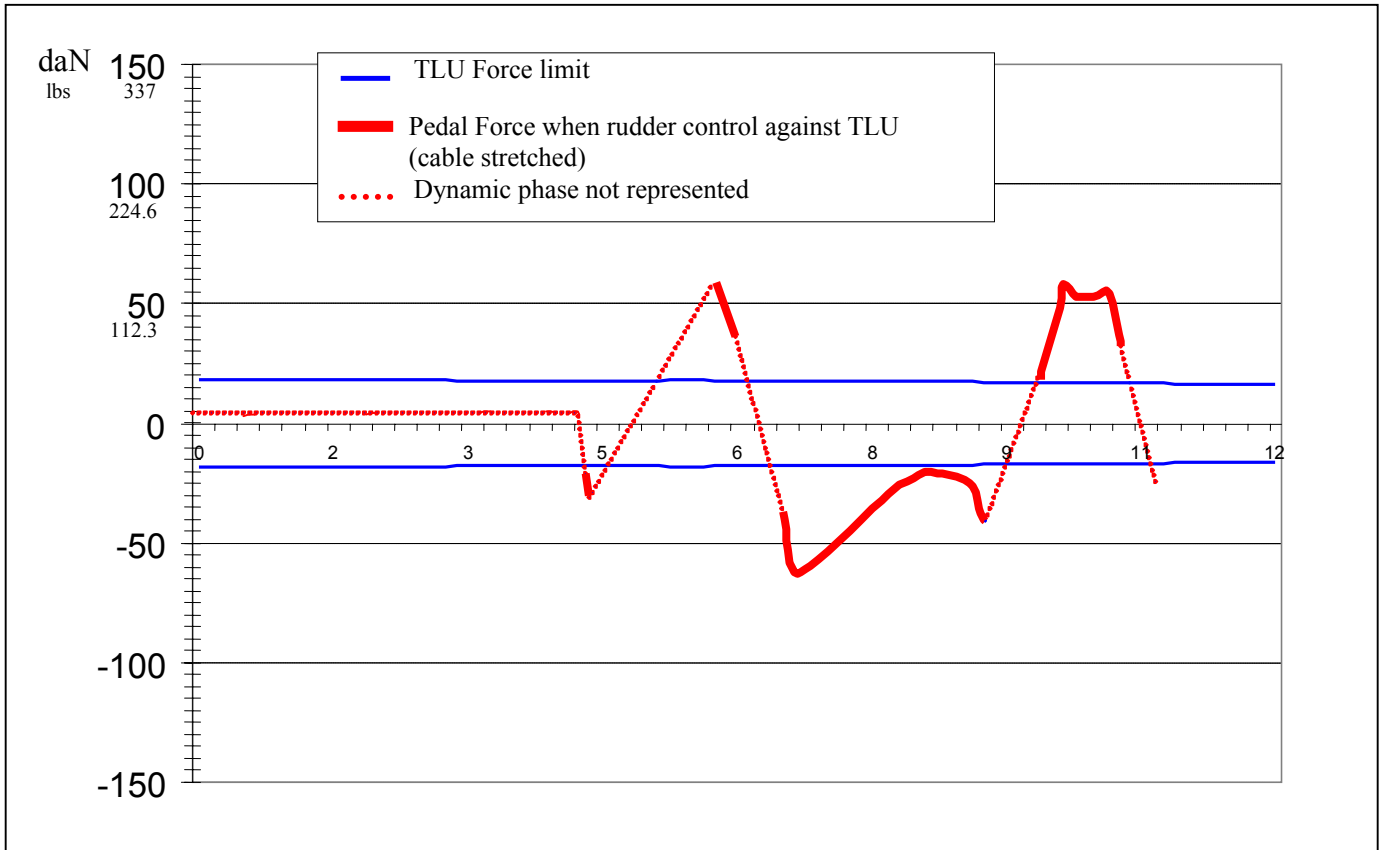
The analysis of the First Officer voice characteristics shows that the First Officer exerted large physical effort several times during the second encounter (refer to Human Performance speech report).

These physical efforts are confirmed by the amount of force applied on the rudder pedals over time during the second encounter as shown on the following graph from Technical note ref : C27D03017000 V3.

Estimated pedal force derived from the pedal, rudder and yaw damper positions as identified in the TN: 517.0082/2002 “AAL 587 – Handling qualities investigations” and the control system elasticity as measured on production aircraft.

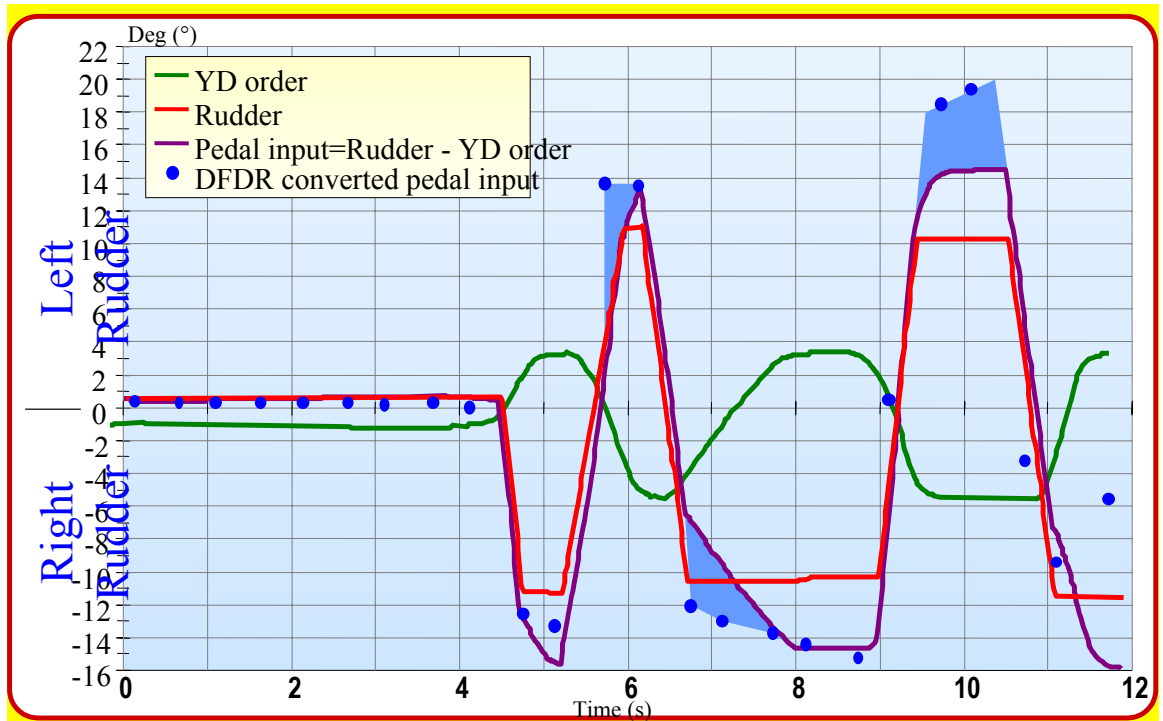
In the A300B4-605R design, rudder deflection results from the addition of the rudder pedal order and the Yaw Damper order, limited by the TLU. During the second vortex encounter where the pilot made very large rudder inputs, there were two instances where the rudder pedal deflections were greater than required to hold the rudder against the Rudder Travel Limiter. This difference is due to mechanical elasticity in the linkage due to the very high forces that were applied to the rudder pedals. This difference also indicates that the observed rudder motion was neither due to abnormal system behavior nor to a system failure back-driving the rudder pedals.

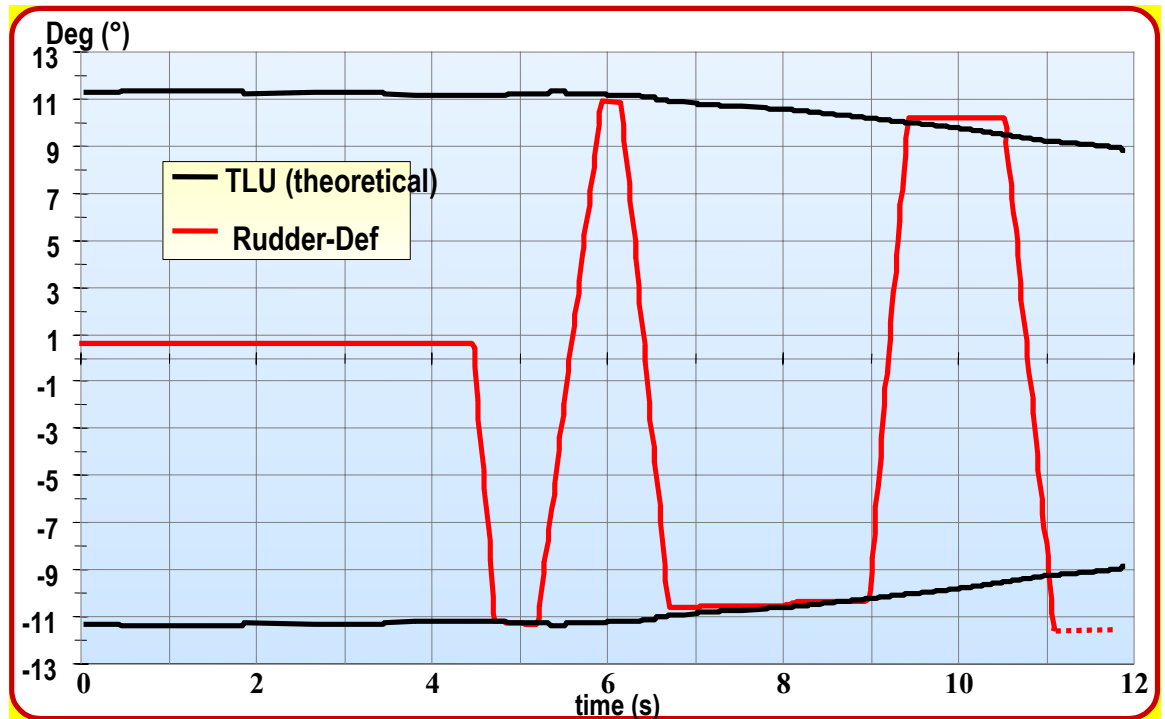
These very high pedal forces (up to 140 lbs) also prevented the Rudder Travel Limiter from fully matching the theoretical limit as a function of  $V_c$ . The end result was that, just prior to separation of the vertical fin, the rudder deflection exceeded the design limits for that airspeed, on two brief occasions.

The Travel Limit Unit (TLU) is driven by an electrical motor. This electric motor moves the variable stop to reduce the maximum rudder deflection as speed increases. However, when very high forces are applied on the pedal (around 240 pounds), the electric motor cannot move the variable stop further in the closing direction. If this occurs while aircraft speed is increasing, it is possible for the rudder deflection to exceed the desired limits. This phenomenon was most probably present during both exceedances shown on the previous chart.

In addition when subject to high forces, the variable stop can be slightly deformed, thus allowing an additional small rudder deflection (maximum 0.7 degree). It is important to keep in mind that by design, the rudder authority is as such that there is no operational need to ever apply rudder pedal input up to the rudder stop in flight.

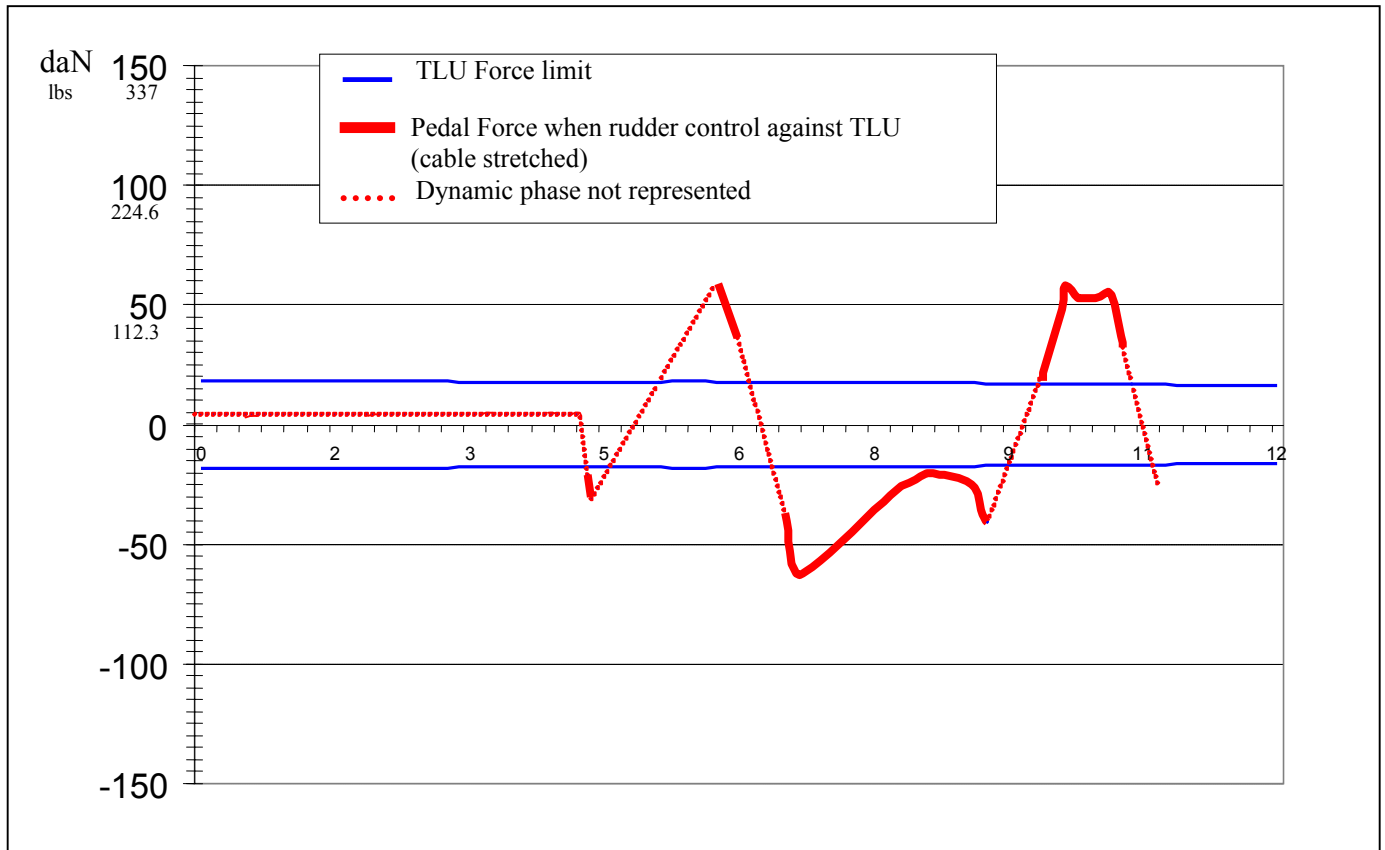
The following chart shows the amount of force applied by the co-pilot to the rudder pedals during the second wake encounter.

It is clear from this chart that the co-pilot applied forces (up to 139 lbs) on the rudder pedals far above the maximum value required to reach the rudder stops for any Commercial Air Transport category airplane. This demonstrates that his objective was to reach the pedal stop as quickly as possible, just as he was taught during AAMP training.

From these data, it can be concluded that, should the aircraft be equipped with a VLA design, the pilot would have similarly targeted and reached the pedal stops. It might have taken a bit more time to get there. But because of his AAMP training, it is believed that a VLA design would have made no difference in the outcome. As is seen from the DFDR analysis it was during the two-second period, when the co-pilot held the rudder pedal on its stop, that the sideslip had time to develop. Assuming that the aircraft had been equipped with
