Docket No. SA-522

NATIONAL TRANSPORTATION SAFETY BOARD

Airbus Vertical Tail High Loads for In Service Events

- **LE10 - Vertical tail high loads in service events**

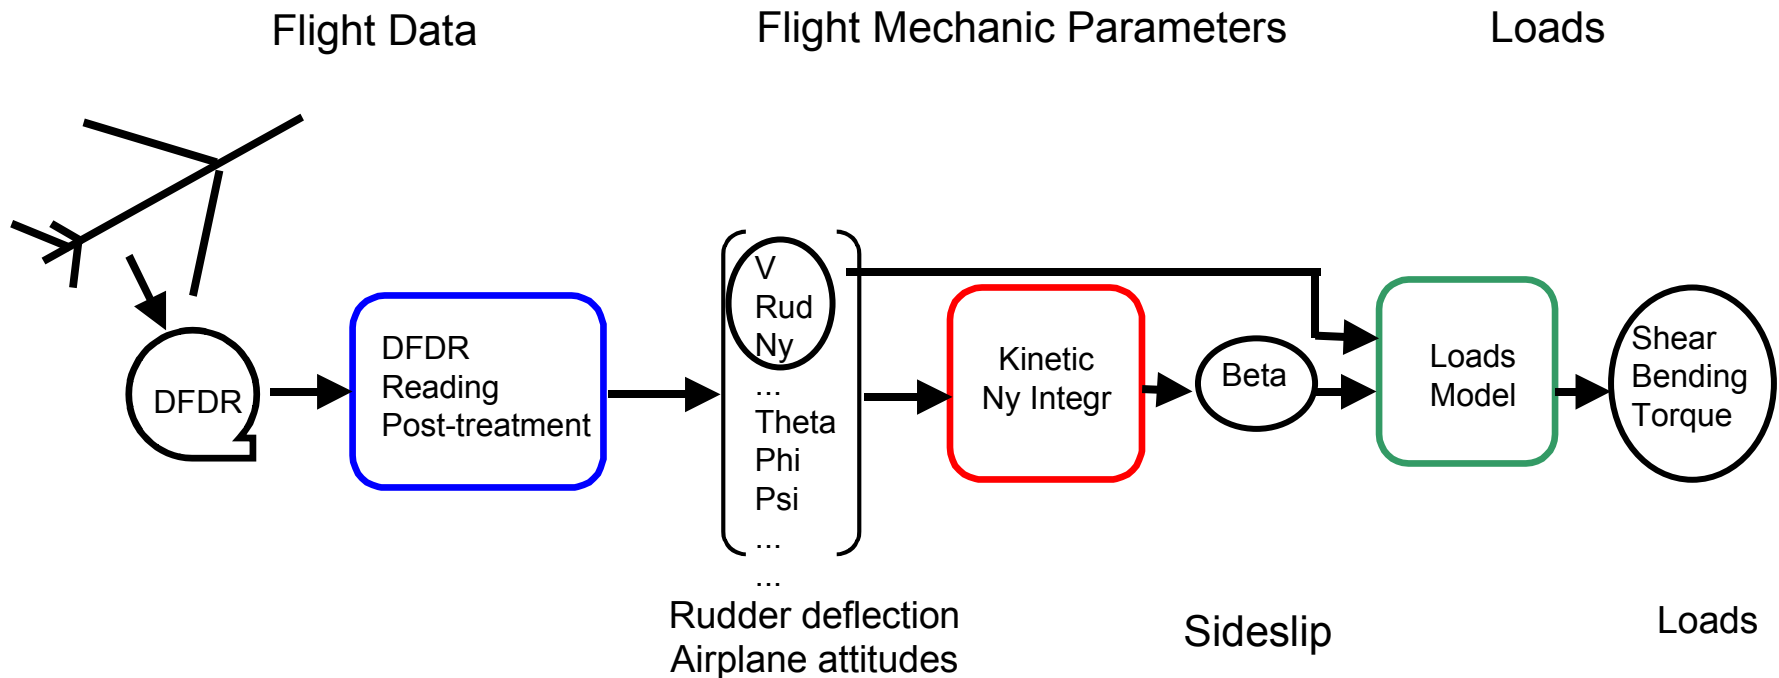
- Event analysis principle

- Kinetic/Ny Integration method used.
- Process applied
